How Best Management Practices Can Protect the Edwards Aquifer

By Sarah Hernandez, St. Mary's Hall student

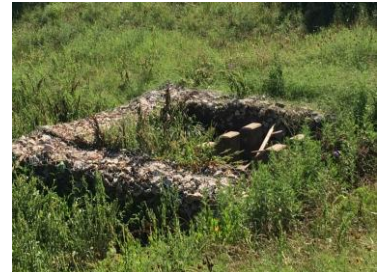
Sometimes, certain additional structural choices are made to slow the flow of runoff and to separate larger units of pollution, such as with the use of concrete blocks or a rock gabion as shown in the image to the right.

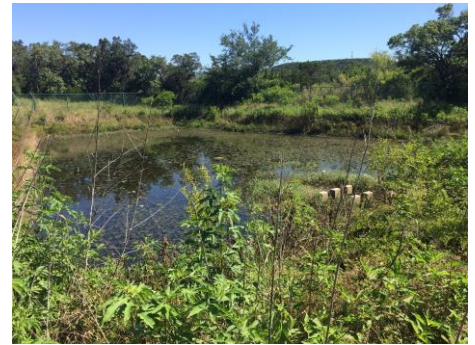
In order for these water quality basins to serve their purpose, however, they must be maintained. The San Antonio Water System (SAWS) is in charge of performing annual inspections of all the sand filtration basins within the Edwards Aquifer recharge zone. When SAWS locates a basin that is not being maintained, they work with the property owner and the contracted maintenance company responsible for the given basin to produce an action plan and to enforce best management practices. Still, many basins fail to meet maintenance requirements. To the right is an image of a basin that fails to meet maintenance requirements.

This basin is not functioning, as it is retaining the stormwater for over 48 hours past a given rainfall event rather than allowing it to infiltrate into the ground. The basin no longer has the capacity to collect the designed amount of stormwater (1.5") and is not allowing collected stormwater to filter properly. Another maintenance task is to ensure that the orifice, the main pipe allowing stormwater to enter the basin, does not become blocked or clogged with debris. Other maintenance includes: identifying and repairing areas of erosion; removing sediment and debris, especially from the drainage pipes and in and around the pond; and maintaining vegetation so that infiltration is still possible. The following images show a basin overgrown with vegetation and backed-up with sediment and debris.

quality within the Edwards Aquifer. The images shown above in the previous section highlight some of the water quality basins that GEAA identified as out of compliance. BMPs could reach this condition for a number of reasons, the first being that they are not listed on SAWS' or another city organization's list of basins to maintain. Another possible reason includes a chronic non-compliance on the part of the party responsible for its maintenance. In this case, the issue could possibly have been sent onto TCEQ who can levy stronger penalties. Finally, insufficient inspections can be credited for a basin's lack of maintenance, as recent and or short-term non-compliance is not noted.

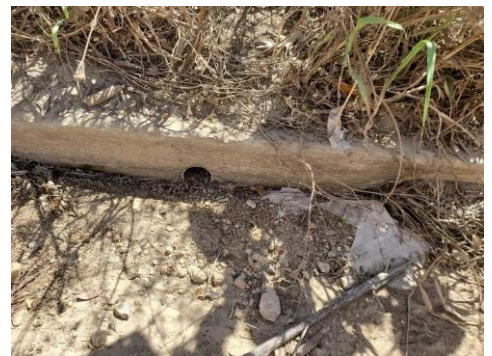
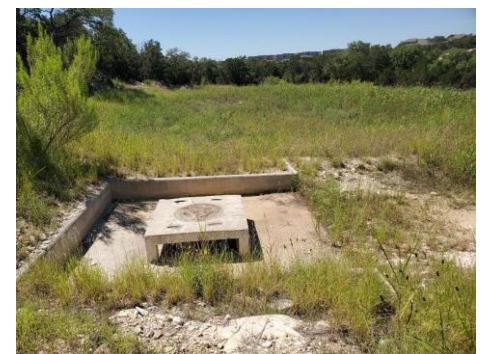
Due to sediment buildup, the basins shown do not allow the stormwater that is flowing into these ponds to flow or infiltrate the aquifer at a steady rate. Furthermore, the sediment in the basin forms a hard crust which prevents the basin from collecting the designed amount of stormwater and allowing it to be filtered and discharged into the aquifer properly. Basins that are not maintained cause the same problems that uncontrolled runoff can, including flooding around the basins and residential areas, an unchecked spread of debris, and further contamination of waterways and the aquifer.
