**Greater Edwards Aquifer Alliance Report:**  
**San Antonio Parks and Recreation Soil Health Assessment**

April 7, 2023

Prepared for:  
City of San Antonio  
Parks and Recreation Department  
Horticulture Services

Prepared by:  
Deborah Reid Nathan Glavy, Technical Directors  
Greater Edwards Aquifer Alliance

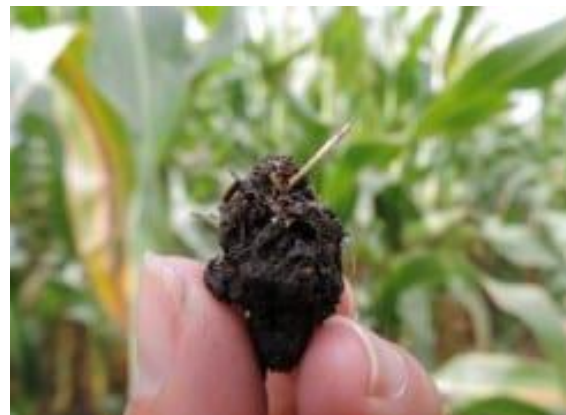
Figure 5: Aggregated Soil.

Soil aggregates are clumps of soil particles that are held together by moist clay, organic matter, root exudates, gums (from bacteria and fungi), and fungal hyphae (Figure 5). Soil aggregation and the development of soil structure play a crucial role in determining soil functions and ecosystem services<sup>11</sup>.

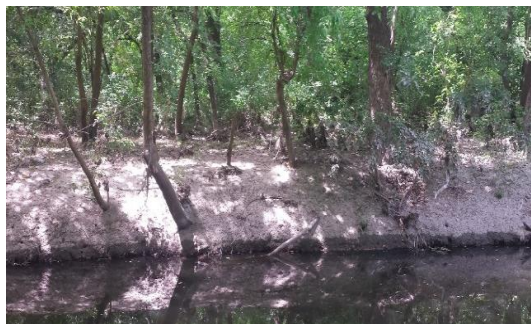
Figure 9: Olmos Basin Park parking area.

such as seen in Figure 9, where restoration efforts could increase not only carbon sequestration, but also flood resilience.

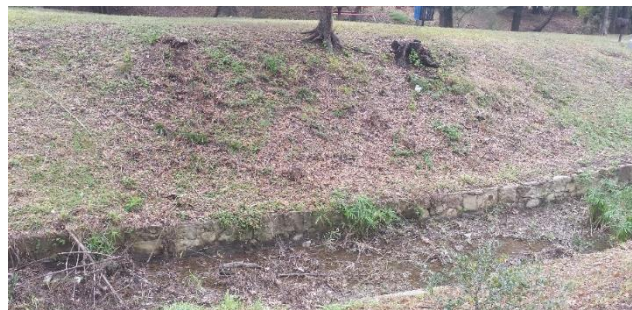
Figure 10 : Brackenridge Park tributary that leads to the San Antonio River at the Hildebrand entrance.

Other park sites, such as seen in Figure 10, can be improved immediately by allowing vegetation on slopes to grow to 5- 6" while never mowing less than 4". Additional tree planting would also improve functionality and soil health.

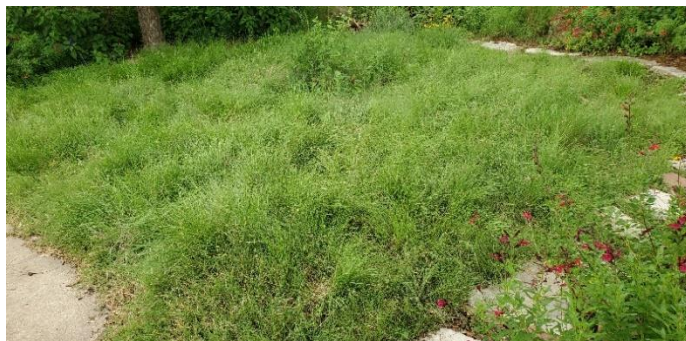
Figure 13 : A monoculture of Webberville sedge allows for easier maintenance by removing what is not the sedge.

In Figure 13 the approach implemented is creating “pocket” sites with the use of small monoculture areas to facilitate maintenance, “if it is not the desired plant, then it is removed”, eliminating the need for species identification.

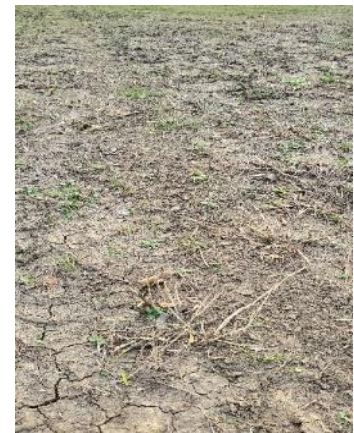
Figure 14: Soil surface crust created by mowing regime, erosion and drought.

Another result of soil crusts is the unseen negative impacts on the environment by increasing air and water pollution. When soils are in an increasing state of degradation, they not only have a reduced ability to sequester carbon dioxide from the atmosphere, they become a net source of greenhouse gas as microbes continue to break down SOM in an unsustainable manner<sup>22</sup>. Also, the erosion from such surfaces is considered a non-point source pollutant, which is one of San Antonio’s greatest water quality challenges

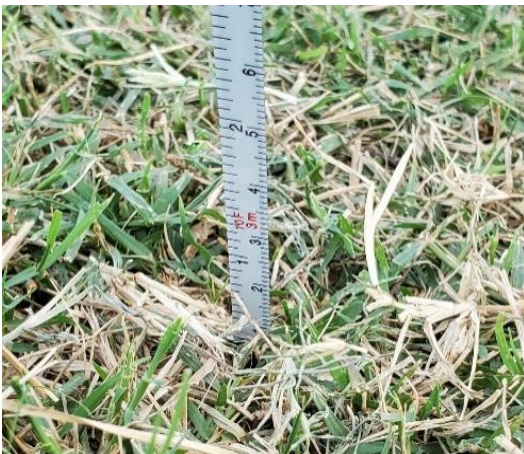
Figure 15: Two-inch turf height after mowing operations in Milam T Park.

And while there is a policy to mow a minimum of 3” height, this is often not reflected in the field, as shown in Figure 15, where vegetation measurements were taken shortly after mowing operations at Milam Tealer Park.

Most commercial mowers offer a 3.75” or 4” cutting height. It is recommended to cut at the maximum height whenever possible and have the height set by a supervisor. On a park site, have the line trimmers begin with edging operations, allowing the mowers to set the height as a guide for any additional line trimming to reduce scalping.

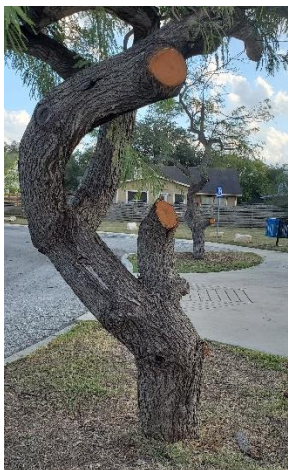
Figure 21: Improper Pruning of Argentina Mesquite.

Without proper pruning trees become diseased and decay can lead to future failures and removal before their time.

To minimize the negative impact of improper pruning, it will be important that only maintenance staff or contractors that have received training be allowed to prune trees. This requirement should also apply to property lessees such as those leasing sports fields that may be responsible for the area's maintenance.

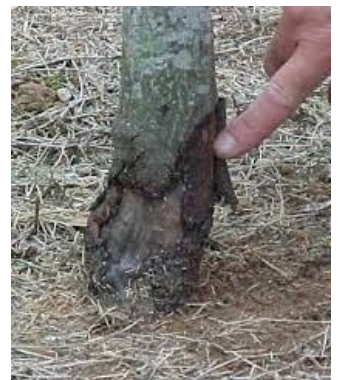
Line-trimmer damage will not only damage a young tree but can kill it. This damage is caused by cutting the line of cells (located just under the bark) that transfer water from the roots to the tree canopy. Prevention requires that the trunks of newly planted trees be protected for 3-5 years as a line-trimmer operator's goal is to reduce the height of vegetation around tree trunks. Eventually, most trees produce a thick enough bark to protect themselves.

Figure 20: Line Trimmer

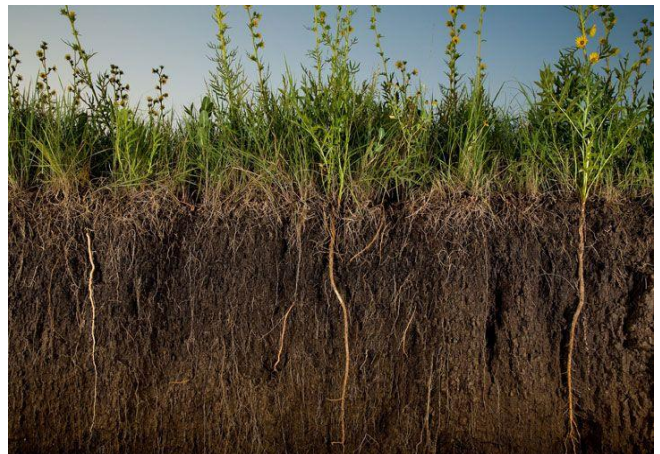
Figure 22: Maximizing root mass for healthy soils.

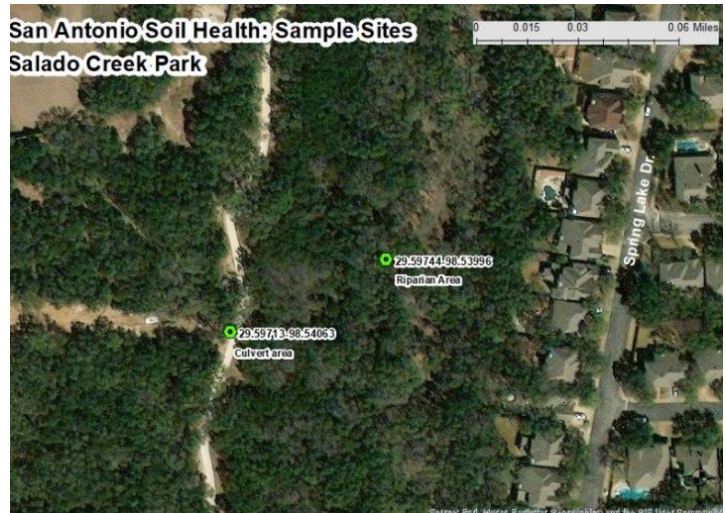
At this time, there are no recommended changes to maintenance practices. This section of the creek could be used as an urban reference reach as indicated in Figure 24. The goal for this site and the entire riparian area within the park will be to protect it from impacts such as upstream development or projects that could change flows within the creek. It will be important to monitor the site for impacts from the Loop 1604 widening project.

Figure 24: Riparian Site with Healthy Stands of Eastern gamagrass.

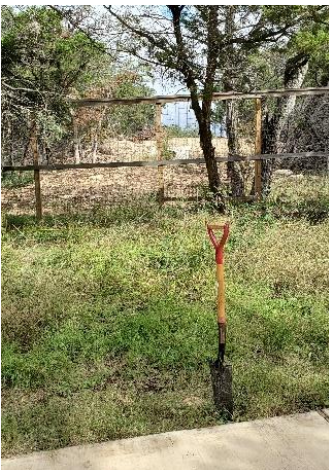
Figure 25: Culvert Site showing sediment deposition from the abutting property.

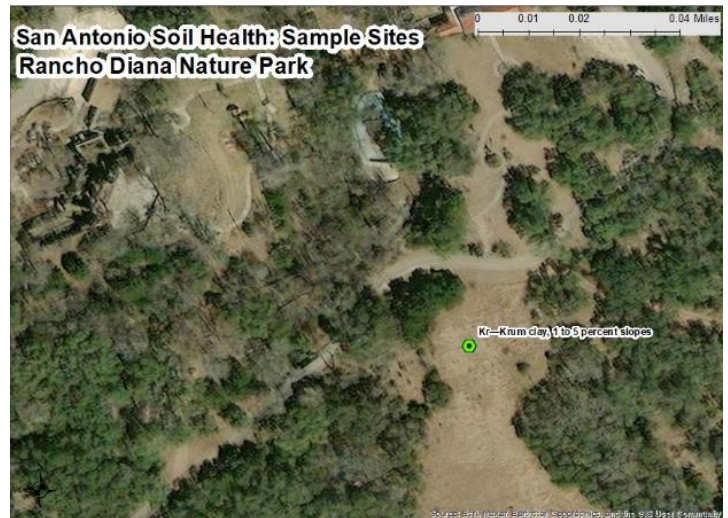
While rooting depths such as seen in Figure 26 may not be achieved on this shallow upland site, maximizing live root mass will go a long way to not only improving soil health but also increasing its depth. A desirable ratio for prairie grasses to fulfill their potential in sequestering and storing carbon is a **1:3 ratio of above-ground to below-ground mass**.

Figure 26: Example of native prairie grass root growth potential.

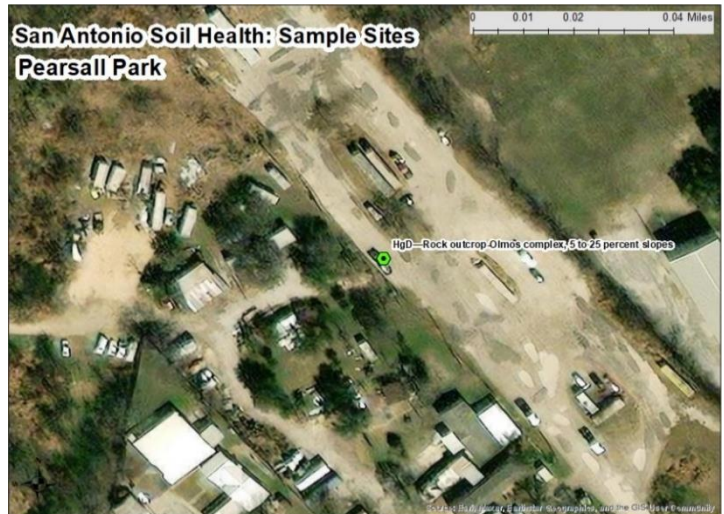
This site had the lowest readings across all of the soil health test parameters. The lack of vegetation and compacted soils can be seen in Figure 27. By applying a mixture of BMPs and increasing maintenance for the area for a year, the site should readily improve and provide an example of effectiveness within 2-3 years. If observations indicate that there is significant improvement, it is recommended to retest and compare differences in the before and after treatment results.

Figure 27: Sampling Site at Pearsall Park

- Surface tilling to break the crust.
- Creation of a bioswale or berm parallel to the fence and sidewalk that would accommodate mowing.
- Add a soil amendment to the entire site.
- Plant with a sod-type ground cover and additional trees.
- Weed and water appropriately for a growing season ensuring a minimum of 75% vegetated cover.
- A rain garden with interpretive signage would not only be beneficial to the site but would also increase awareness within this socially vulnerable community.

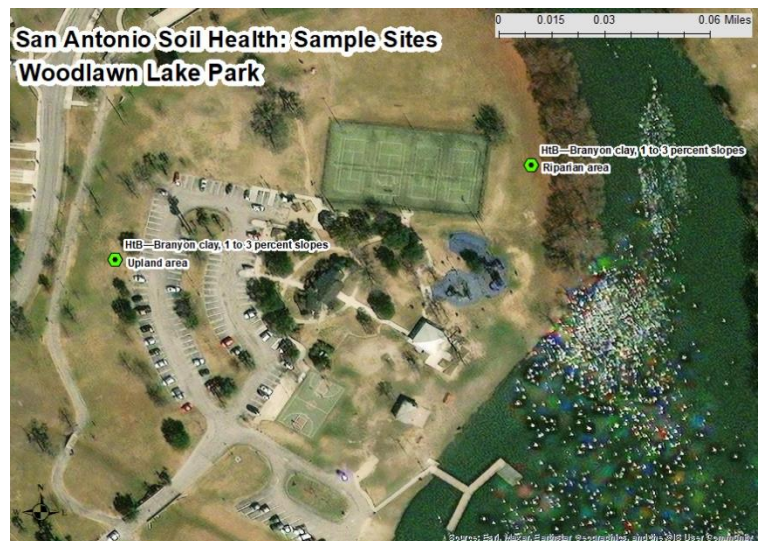
While the riparian sample site has a line of healthy Bald Cypress trees, there was basically no understory or riparian plant buffer as seen in Figure 29. While any initiatives would require public input, a recommendation with minimum changes is given:

Figure 29: Woodlawn Lake Park riparian Site

The selected site was strategically located between the fence surrounding the tennis courts in an area with less traffic but high visibility. The area from the fence down the slope to the water's edge would include a walking path (along the length of the fence) with a mulch surface. This path would provide an alternative path from the hard packed area at the water's edge.

this designated walking path would mark the edge of the small drainage area that would direct low flows into a very low bermed bioswale just outside the proposed 10-12' riparian buffer. The bioswale would provide additional moisture for plantings in front and behind the small berm.

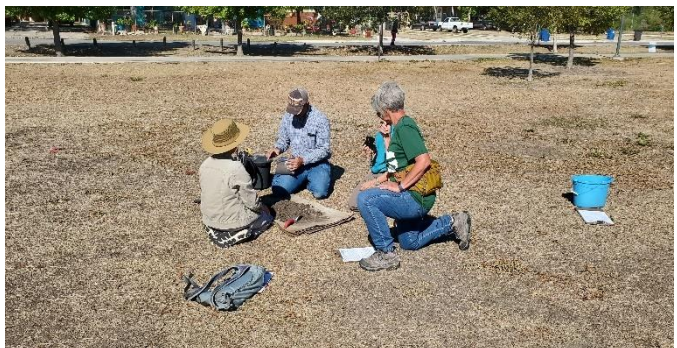
Figure 32: Upland site was location for Master Naturalist volunteers to receive instructions from NRCS staff on how to collect samples to be used for soil health testing.

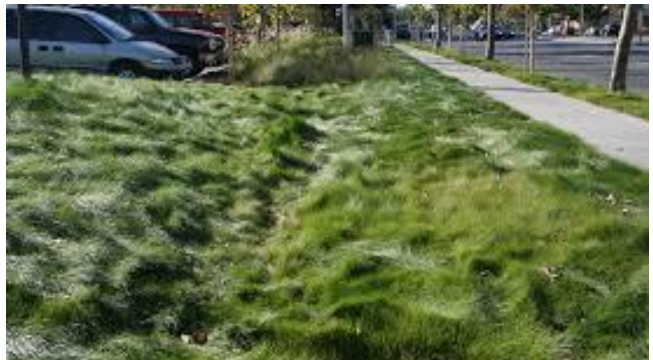
Creating a curb cut within an existing curb can be completed with Parks' staff. Also utilizing a monoculture of a native, drought-tolerant plant such as the sedge shown in Figure 31 could reduce ongoing maintenance and provide year-round filtration services and aesthetics.

Figure 31: Bioswale Planted with Sedge Species to Facilitate Maintenance.

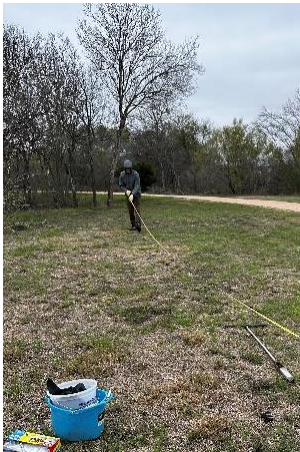
Figure 33: Pocket Prairie Site at Milam Tealer Park

The Pocket Prairie site (Figure 33) will be incorporated into the newly selected mowing standards for the park. It is recommended that the site receive at a minimum the highest setting possible and be mowed only during growing seasons while the abutting picnic table area receives the new “regularly” standard at 3.75”-5” ht.

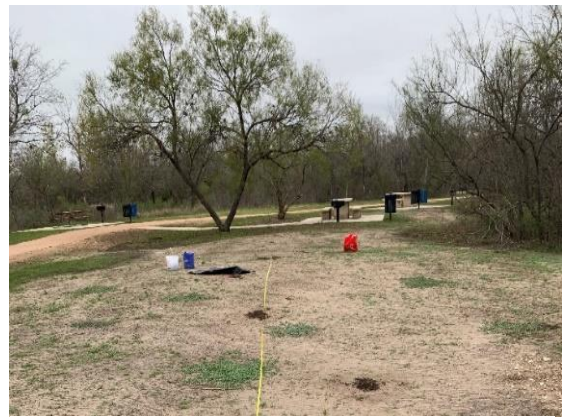
The upland site in Figure 32 reflects the results of conventional mowing operations that occur in parks with high public use where mowing height averages 1.5”-2” and even less where line trimmers are used. Therefore, modifying mowing practices will be the first step in improving not only soil health but water quantity and quality in the lake.

Figure 32: Upland site at Milam Tealer Park

1. No mow/let it grow zones
2. Mow at higher levels
3. Mow less frequently

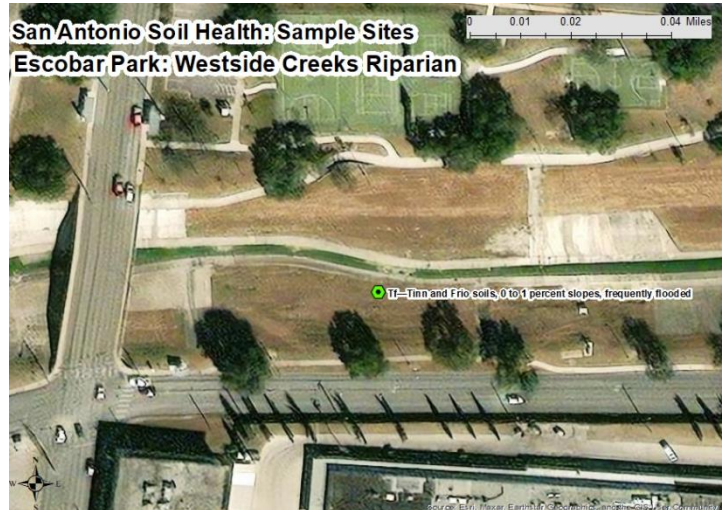
Soil health test results reveal that this area functions at a very low level. Unfortunately, this site also has limitations due to its high public visibility and stormwater conveyance requirements. Any BMP implementation other than increasing mowing heights will be limited to the areas from the top of the channel banks to the abutting streets or trails.

Increased mowing heights and additional tree plantings will increase the area's potential to provide greater ecosystem services and reduce summer temperatures. It will be a good site for monitoring the potential for these 2 basic BMPs within older drainage systems.

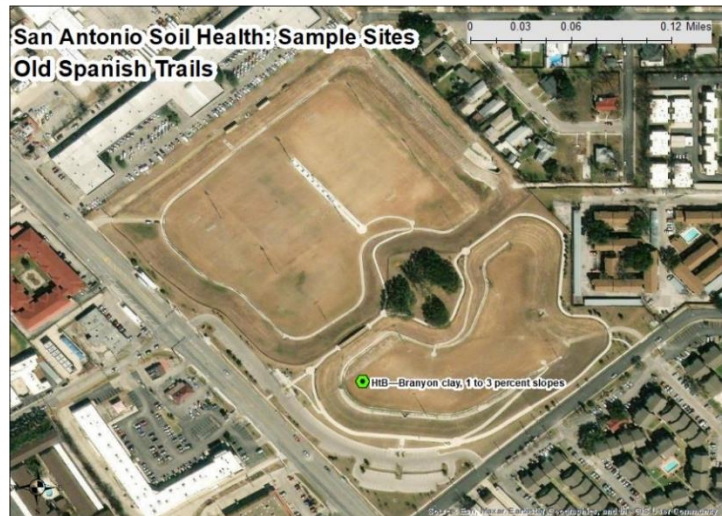
### 14. Old Spanish Walking Trails

This site offers a unique opportunity to increase not only ecosystem services but also capacity within the stormwater detention facility. Overall soil test results rank the soil as average in comparison to other sites which could be improved by modifying mowing regimes.

Working with the leasee, additional strategic areas could be planted with the pocket prairie concept; native grasses and wildflowers cut 2x per year.
