Greater Edwards Aquifer Alliance

Lorence Creek HOA Retrofit Project

**Funded as Lorence Creek Stormwater Retrofit and Research Project
Under the Proposition 1 Edwards Aquifer Protection Projects**

January 25, 2023

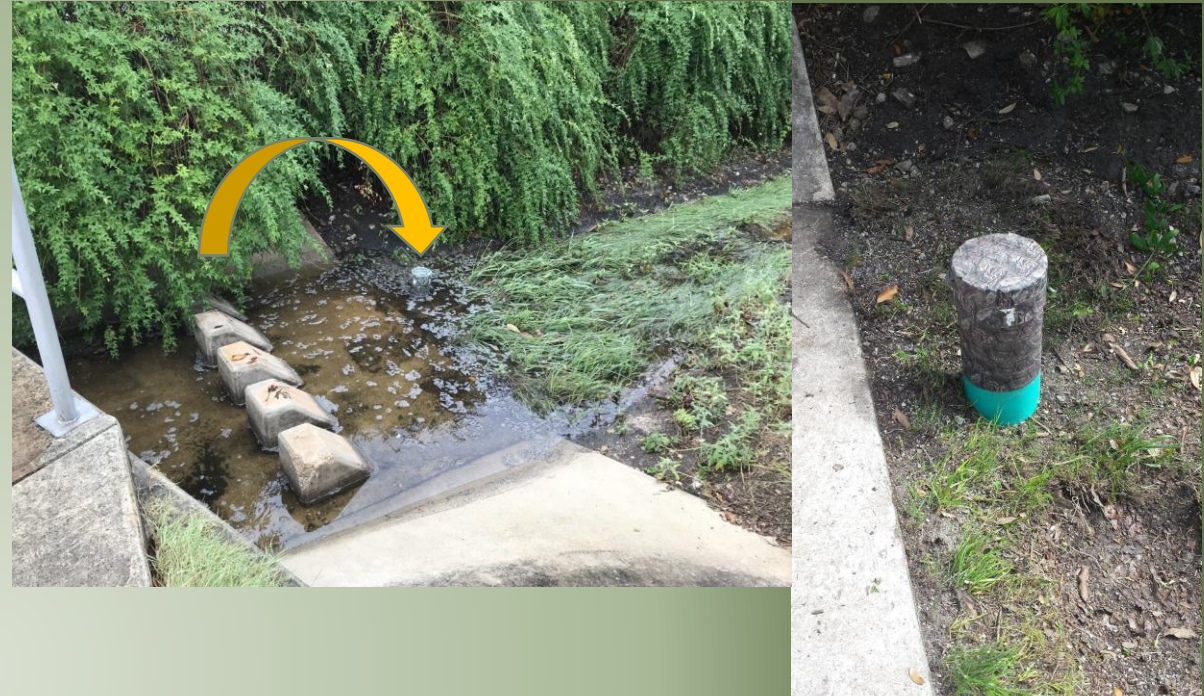
- Sampler was situated at the outfall that collects stormwater from the 26.1 ac drainage area.
- Sampling unit contained a single-phase sampling bottle.
- 5 stormwater samples were collected from “qualifying” rain events along with 5 soil samples.

Single-phase sample bottle

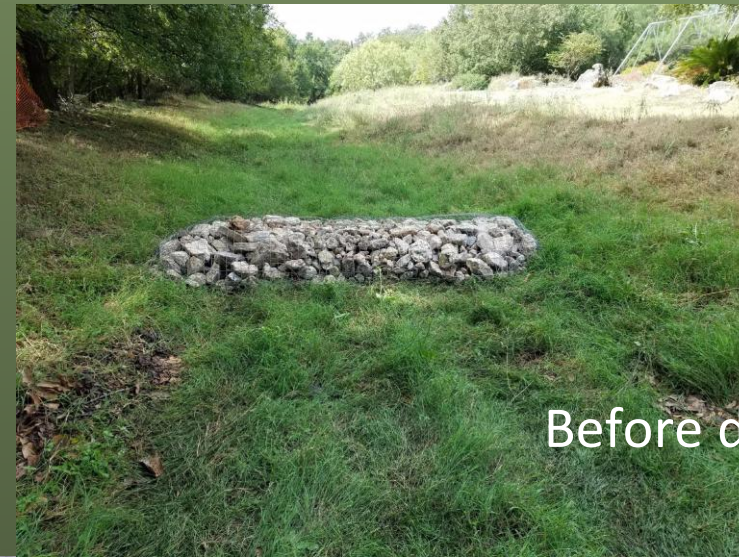
- Installation of the SWAPP feature, a rock gabion across the channel
- Desilting and revegetation of the channel to the rock gabion.
- Percolation rate analysis within future bioretention area.
- Tree protection installed with mulch.

Before de-silting

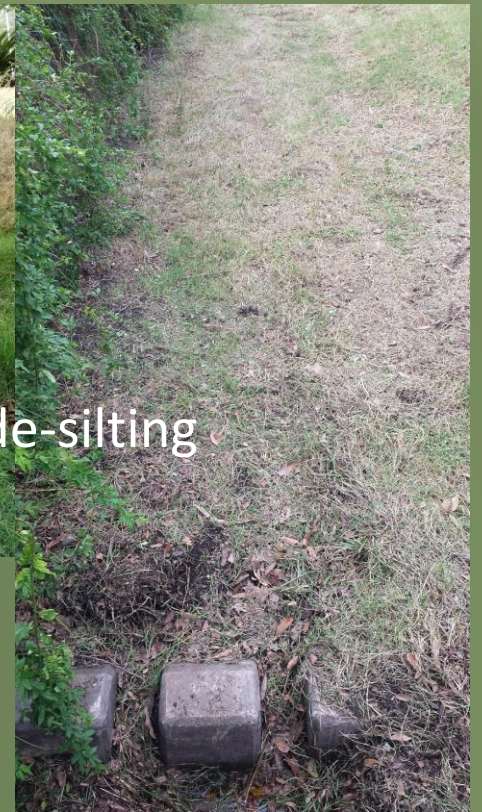
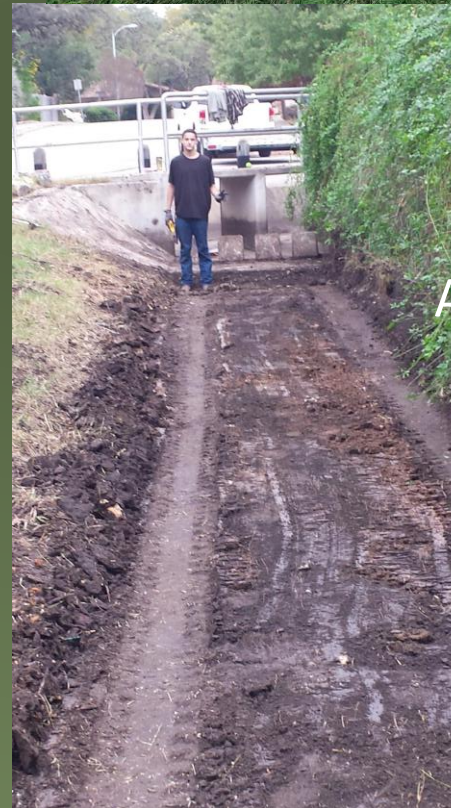
After de-silting

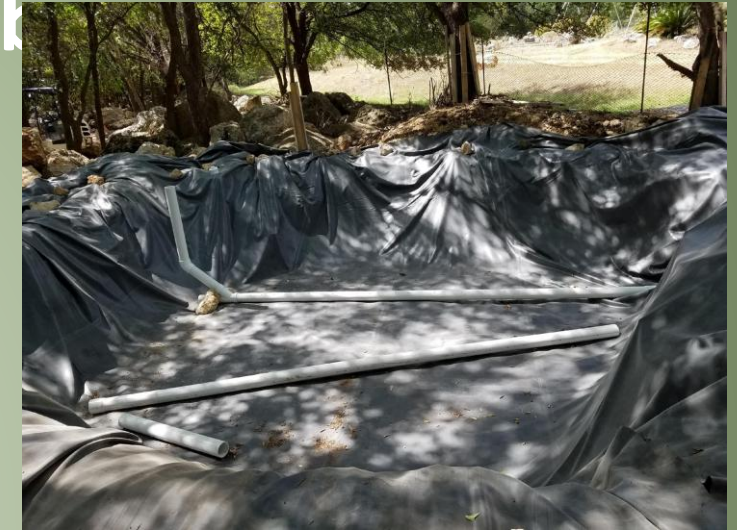
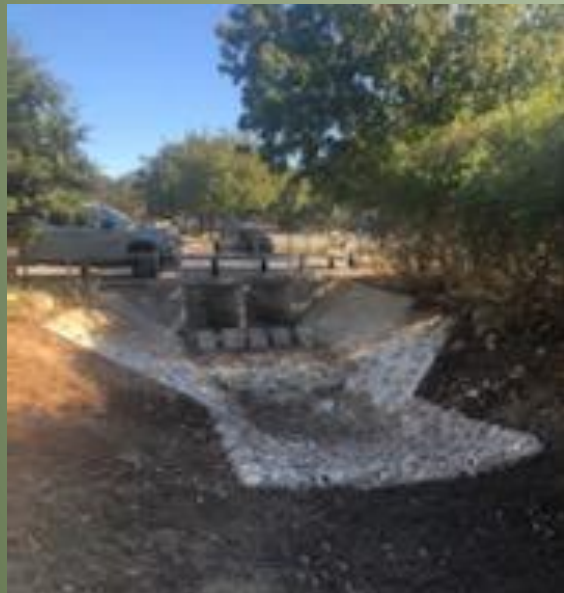
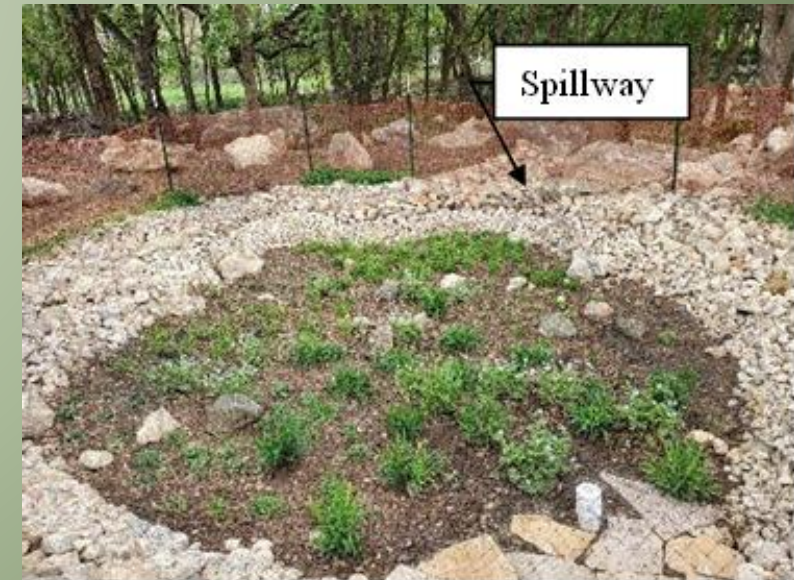
Bioinfiltration

This treatment train directs flow into the enhanced natural bioretention area – the area calculated to treat 0.5”.

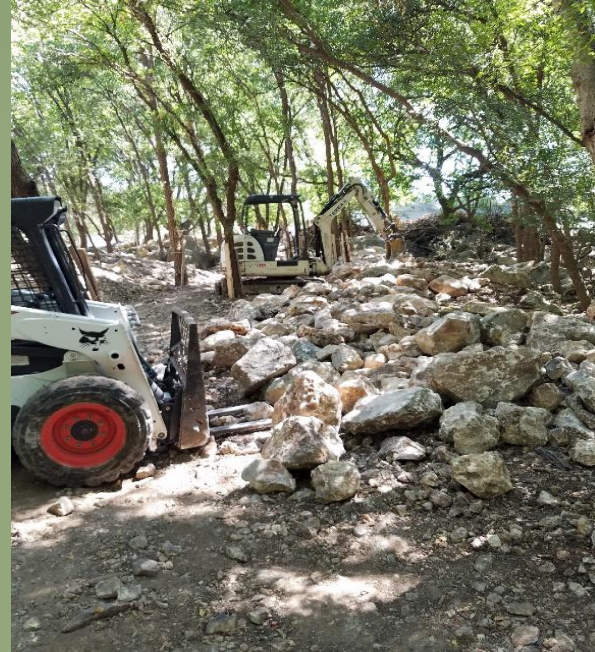
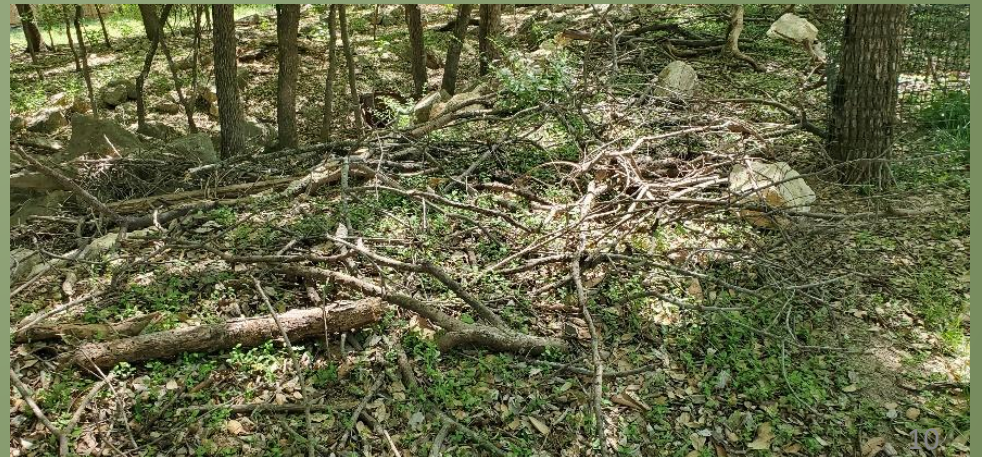
Enhanced Natural Bioretention Area

- An existing rock berm on one side and a partial on the other side were used.
- This partial berm was extended with rock on site, and the entire berm was covered with an impermeable barrier.
- Creative strategies were required to protect re-vegetation efforts from local deer.

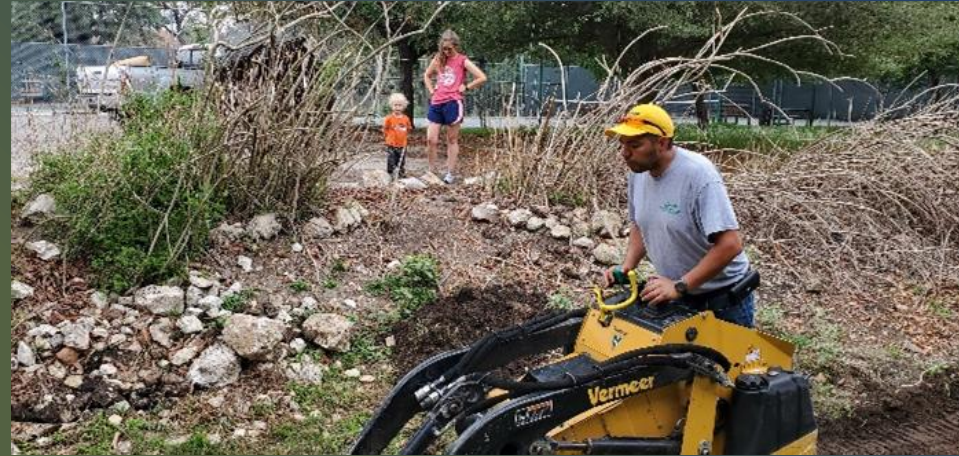
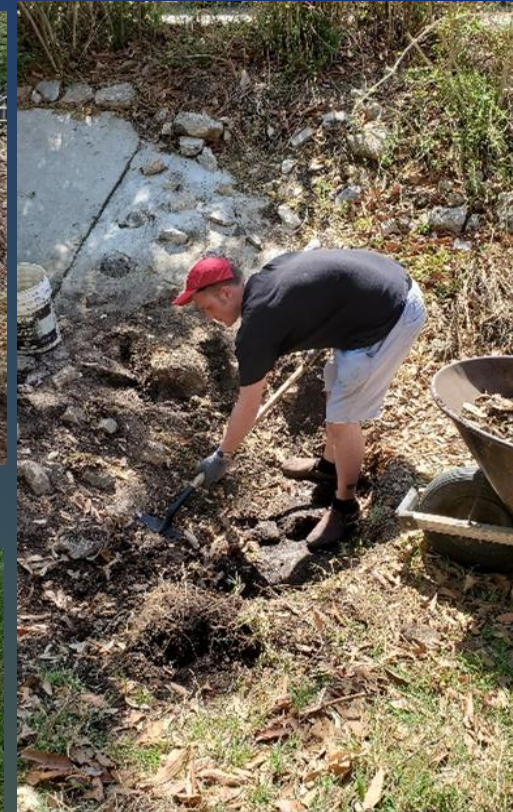
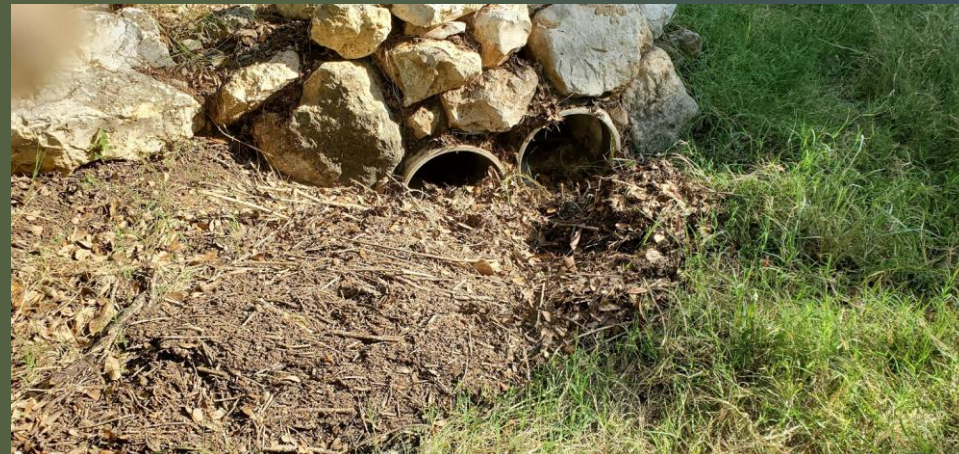
- Removing sediment from the sediment forebay.
- Removing debris from in front of the diversion culverts,
- Keeping plants protected from deer and alive during drought conditions.

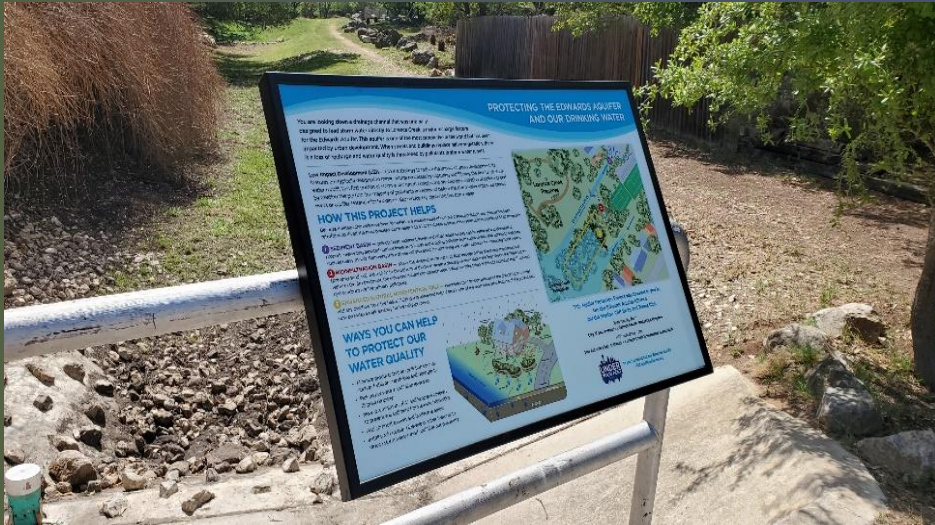
Interpretive sign on site
